Office of Inspections
Office of Inspector General
U.S. General Services Administration

Ventilation Issues Persist in Unrenovated Wings of GSA Headquarters Building

**JE23-001
November 28, 2022**

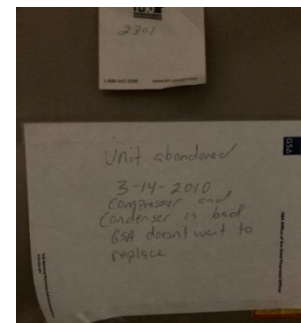
Photo 1

One of the four abandoned AHUs was housed in a conference room closet on the 2nd floor, intended to service the conference room as well as the adjacent office in Wing 0. A note affixed to the AHU stated, “Unit abandoned, 3-14-2010, Compressor and Condenser is bad GSA doesn’t want to replace.” (See Photo 1.)

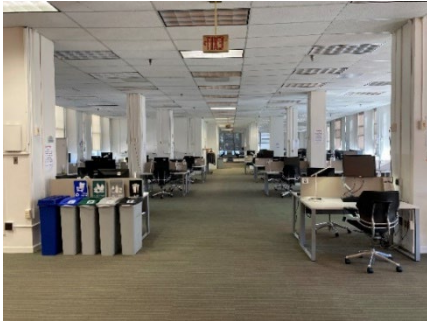
Photo 2

The second unit, servicing the 4th floor, Wing 3 area, was abandoned in place. Neither the Northern Management Services, Inc. personnel nor the Building Manager could determine how long the unit had been abandoned. A third unit, originally servicing the 6th Floor, Wing 3 area, was abandoned in a crawl space between the 6th and 7th floors due to previous remodeling. The fourth abandoned unit originally serviced a ground floor supply room. Because these units were abandoned, they did not supply fresh air to the areas they were meant to service, in one instance for over 12 years.

In February 2022, an inspection by Northern Management Services, Inc., the OIG facilities team, and building management, identified additional missing ducting on the 5th floor, Wing 0. The Building Management Office took action in March 2022 to fix the ducting issue. In April 2022, PBS also took action to install a new fan and ducting for the abandoned AHU servicing the 4th floor, Wing 3.

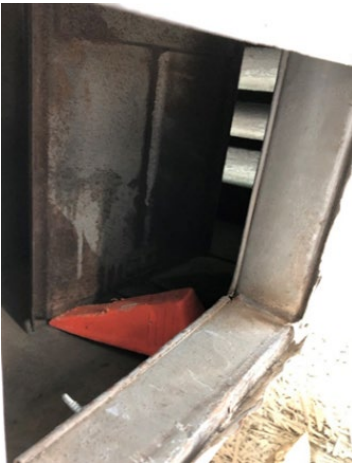
Photo 3

During our site visit, we also identified several mechanically faulty AHU dampers that had to be propped open with objects such as door stoppers to allow the introduction of fresh air when temperatures were above 40° F. (See Photo 3.) We found some dampers held open with binder clips, and

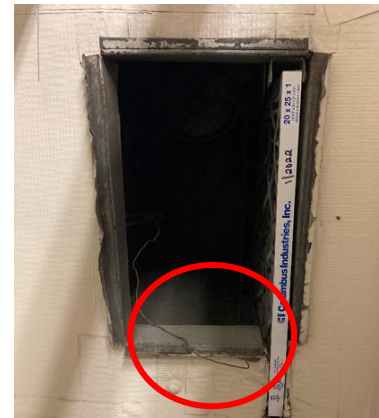
Photo 4

several others jerry-rigged with wire handles to enable the operator to manually open them without having to reach inside the unit. (See Photo 4.)

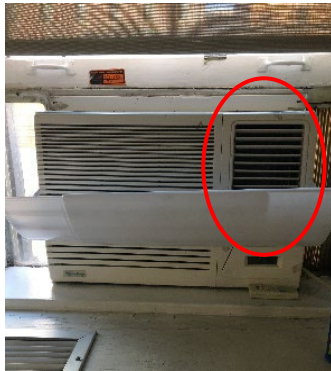
GSA added diverters to the window air conditioning units throughout Wings 0 and 3 to push the air up. However, no one took into account that all of the diverters GSA purchased fit window air conditioning units with vents that are horizontal across the unit, but not vents that are stacked into a vertical panel. (See Photo 6 – with vertical vents on the right and the filter cover on the left.) As a result, the diverters cannot cover all the vents to push the air up, rather than across, the breathable space. Further, we observed that the adhesive used to attach the diverters to the units did not always work, resulting in diverters sliding down and not functioning as intended.

- Diverters were installed on all window air conditioning units (completed December 2, 2021), to minimize the horizontal movement of pathogens (i.e., COVID) in the workplace. A full diverter inspection was completed on November 04, 2022, to identify the malfunctioning diverters from the draft report. Given the failure rate, a replacement plexiglass baffle prototype has been identified and will replace the existing diverters. The new baffles will be installed in the occupied space by November 18, 2022. The new baffles will be installed in the unoccupied space by December 15, 2022. The baffles will be inspected daily while performing cleaning inspections and performing tours of the building.
