Office of Inspections  
Office of Inspector General  
U.S. General Services Administration

**PUBLIC BUILDINGS SERVICE FAILED TO  
ENSURE THE CONTINUED  
MAINTENANCE AND SECURITY OF THE  
PEACHTREE SUMMIT FEDERAL  
BUILDING**

**JE26-003 (Redacted)  
September 23, 2026**

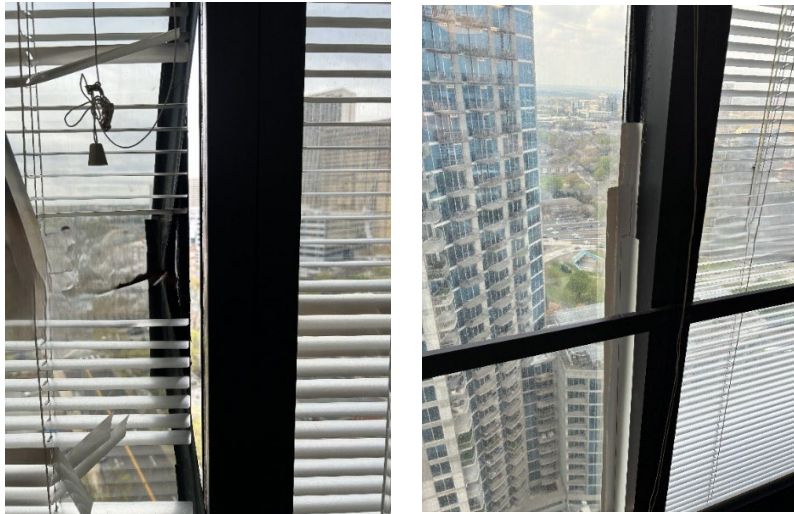
**Figure 8. Damaged Window Seals in Office Space<sup>31</sup>**

However, we found that PBS was not effectively maintaining windows throughout the building, which allowed outside air and water to enter tenant office spaces through damaged window seals. Damaged window seals must be promptly addressed to avoid heating and cooling inefficiencies and the potential for mold growth.<sup>29</sup>

obtain direct feedback on their respective office space conditions. We spoke to four tenants, which represented 60 percent of the occupied space. Most reported having damaged window seals at various places within their office space. These damaged window seals allowed water to intrude into their office spaces or led to disruptive noises.<sup>30</sup> One of the tenants told us they experienced both water leaking into their office when it rained and loud flapping noises coming from the window on windy days. We observed that the maintenance contractor used tape-like materials to seal the gap between the window frame and the wall to address these issues (see *Figure 8* below). According to the tenants, maintenance issues often continued even after the maintenance contractor completed the service request due to inadequate fixes.

- b. Conduct an assessment of all tenant-occupied space in the building to identify poor window conditions and develop a corrective action plan to address those issues.
